## **5.0            EXISTING CONDITIONS**

### **5.1            INTRODUCTION**

## 5.4 CASTRO ADOBE / STRUCTURE

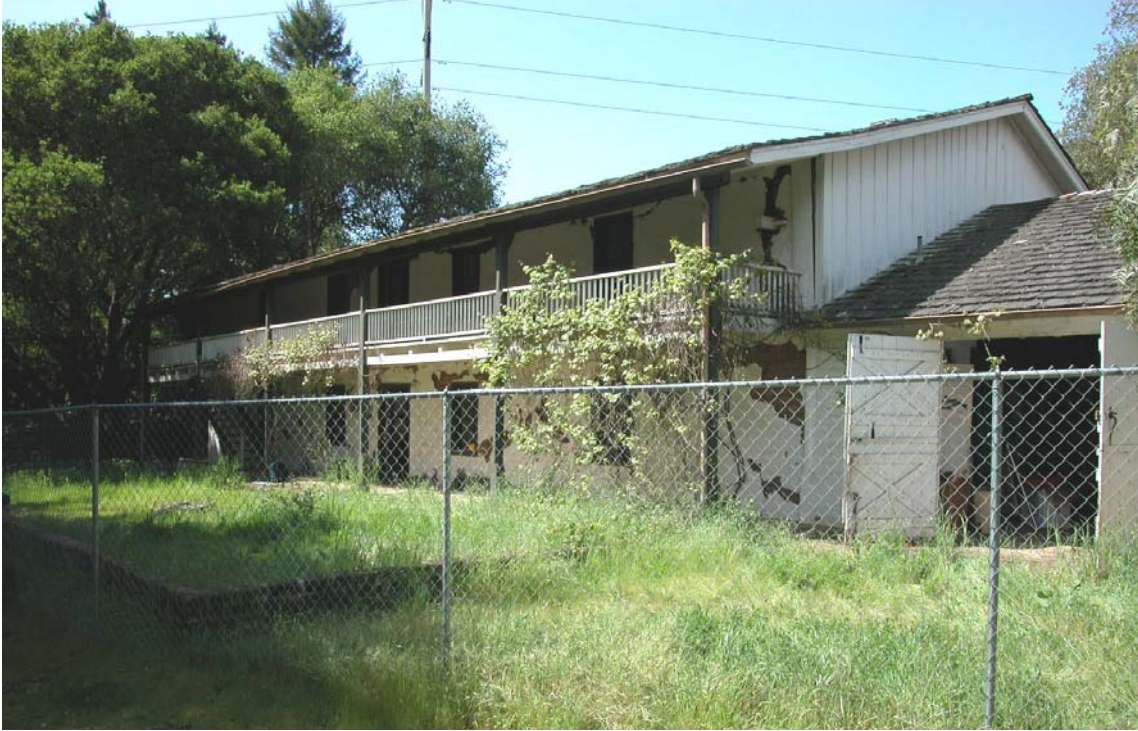
**Figure 5.2:** A view of the adobe from the northeast. The cocina is the lower extension to the right. Digital photograph by A. Crosby, April 2003.

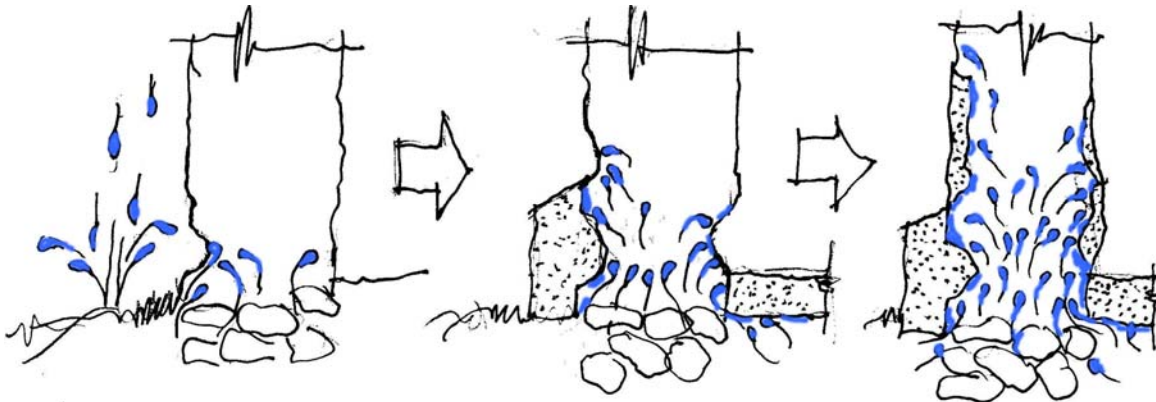
Figure 5.3 is a sketch showing a typical condition of the failure of an adobe wall from the presence of moisture at its base. In the sketch on the left the base of the wall begins to erode from capillary moisture and normal wall splash. As shown in the center sketch, a typical repair consisted of a concrete curb or counter wall, which forced capillary moisture higher in the wall. Hard impervious stucco will have much of the same effect. At the same time a concrete slab was added to the interior forcing even more moisture into the adobe wall, causing additional decay at the base of the wall and above the concrete curb. Further repair using more impervious materials forced the moisture higher, while increasing the overall moisture content and reducing the strength of the adobe. The sketch on the right shows the greater amount of moisture and the slumping and bulging of the wall as it loses its ability to support the weight above. At this point, which

may be immediately before the wall fails completely, there is relatively little visible evidence of the actual condition.

**Figure 5.3:** Sketch of a typical process of failure of an adobe wall from capillary moisture gaining access to the base of the walls followed by inappropriate repairs that exacerbate the problem.

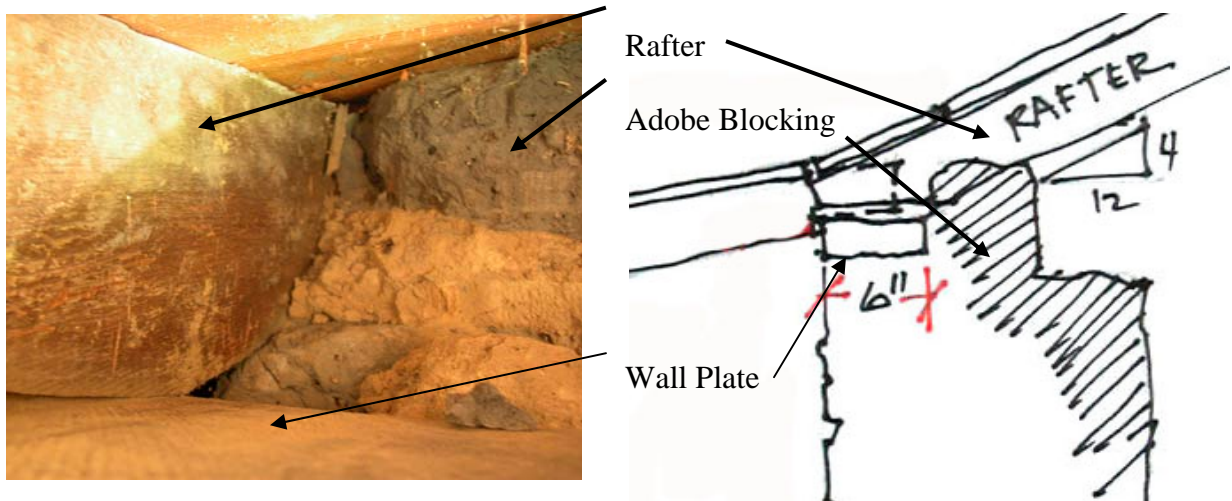
The rafters rest on a wall plate located on the exterior part of the adobe walls. The space between the rafters are filled with adobes, plastered and whitewashed. The wall plate is approximately 3 ½ inches thick and 6 inches wide and is joined by simple lap joints. Figure 5.10 is a photograph and a sketch of this connection.

**Figure 5.10:** Details of the wall plate and rafter connection.
